NAVAL POSTGRADUATE SCHOOL
Monterey, California

THESIS

CHARACTERIZATION OF AN HY-130 STEEL WELDMENT
BY TRANSMISSION ELECTRON MICROSCOPY

December 1981

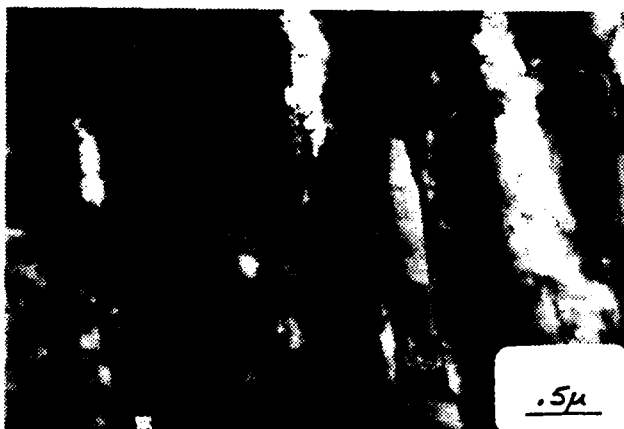
Figure 11

The base metal was examined in the transmission electron microscope to provide a known baseline microstructure. The microstructures presented in figure (11) show several prior austenite grain boundaries, and large spheroidal carbides are seen at those prior austenite grain boundaries and at lath boundaries. The microstructure is indicative of a tempered martensite with large spheroidal carbides. The martensite laths contain a moderately high dislocation density. Lath spacings have been calculated for these specimens and the other specimens and are presented in table (5).

BASE METAL
MICROSTRUCTURES,
DESCRIBED IN TEXT,
ALL PHOTOGRAPHS
AT 22,000X WITH TEM

The base metal microstructures, figure (11), exhibited a tempered martensitic appearance, where the heavy tempering of the base metal prior to welding allowed large spheroidal carbides to be formed. The tempering temperature was held at 620°C for three hours, followed by a water quench. Speich (Ref. 14] showed that a tempering temperature of 400°C for three hours was sufficient for the formation of spheroidal carbides of Fe_3C to form in a low carbon martensite (0.1%C) and this effect is seen in the microstructure of the HY-130 base metal region.

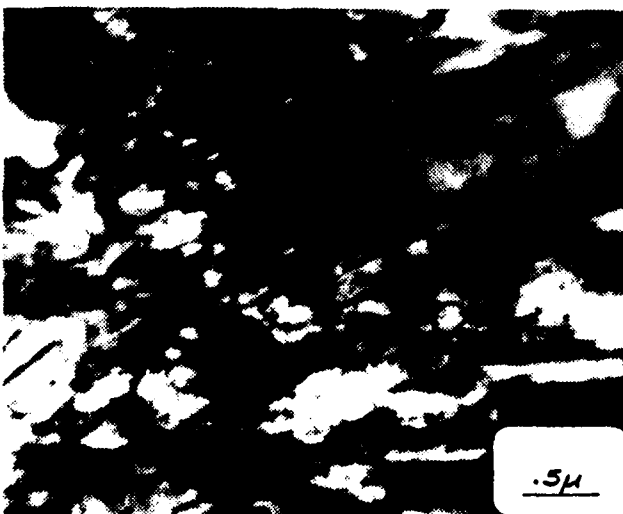
Figure 12

heavily dislocated martensitic microstructure, but the large carbides are still visible, the hardness of all the regions show that they represent the HAZ region nearest the base metal.

MICROSTRUCTURES AT
3.25mm. DISTANCE FROM
FUSION LINE, ALL
PHOTOGRAPHS AT 22,000X
WITH TEM

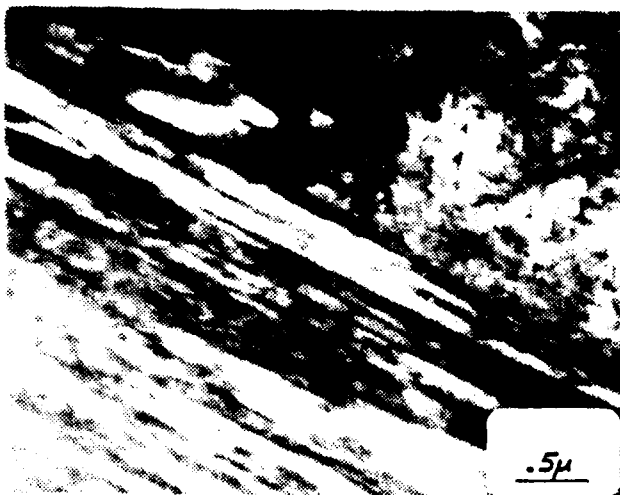
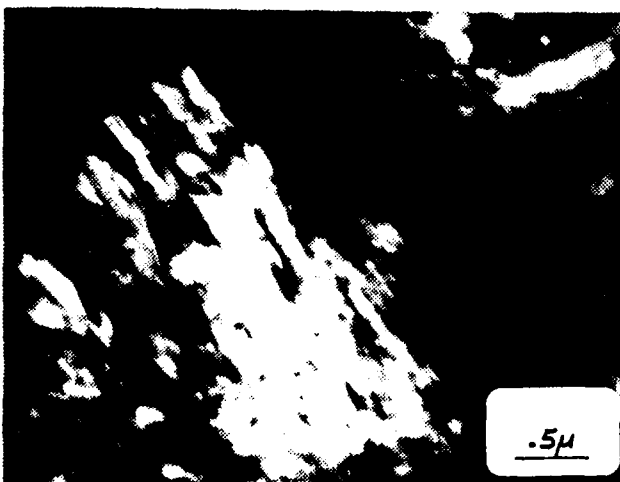
Figure 13

Changes begin to appear in the next region which represents the HAZ at a distance of 2.5mm. away from the fusion line, figure (13). Although the predominant microstructure is still martensite, very few large carbides are visible, and region 3 shows bainite I (upper bainite) with Widmanstatten carbides in a wide bainitic lath as sharply contrasted to the narrow lath spacing of the martensitic microstructure. Region 4 shows some granular bainitic microstructure within a predominantly martensite and bainite I field. Region 2 shows martensite with an occasional ferrite region bordering the martensite-bainite interface. Large carbides encircle the ferrite, and retained austenite is also suspected in this region. Figure (14) shows a ferrite, and typical microstructure of region 3 with the wide bainite I laths shown in contrast to the martensitic microstructure. Within the bainite, large regions of rod-shaped Widmanstatten carbides are present along with martensite. The photo at the right is an enlarged view of the Widmanstatten carbides within an upper bainite region. The corresponding diffraction pattern is shown in figure (14) with the very faint carbide reflections present near the central spot.

MICROSTRUCTURES AT 2.5mm.
DISTANCE FROM FUSION
LINE ALL
PHOTOGRAPHS AT 22,000X
WITH TEM

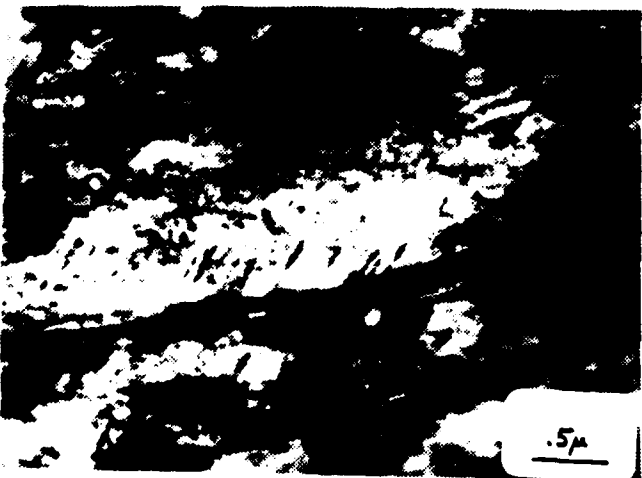
Figure 15

The region examined represents the HAZ at a distance of 1.5mm. away from the fusion line (figure (15)). The large spherical carbides are no longer present. The rod-shaped Widmanstatten carbides have replaced the spheroidal carbides in a predominantly bainite I microstructure. Region 2 shows highly dislocated lath martensite with a finer lath spacing than previously observed. Large regions of bainite are the dominant microstructural features in regions 3 and 4 with region 3 showing very few carbides in the bainite in sharp contrast to the high density of rod-shaped Widmanstatten carbides shown in region 4 in the fairly wide bainite lath. Twins are attributed to segregation of alloying elements in the relatively slow cooled weldment, and are not a dominant feature of this section.

MICROSTRUCTURES AT 1.5mm.
DISTANCE FROM FUSION LINE,
ALL PHOTOGRAPHS AT 22,000X
WITH TEM

The mixture of bainite I - martensite microstructure in the region of the HAZ at 1.5mm. away from the fusion line, (figure (15)), can be reasoned by referring to the isothermal transformation diagram for HY-130 steel, figure (1). For a martensite start temperature (M_s) of 482°C , less than five percent bainite will form in three minutes. Since no large carbides are present in the microstructures, a larger amount of carbon must be in solution than in the previous sections which would lower the M_s temperature, thus allowing a larger amount of bainite to form. The bainite was formed upon cooling from the 1020°C peak temperature experienced in this region during welding and large rod-shaped Widmanstatten carbides were also precipitated within the bainite during the transformation from austenite. Lath martensite is still present in this region, as predicted by the transformation diagram, but the lath spacing is smaller due to the higher cooling rate experienced nearer the fusion line.

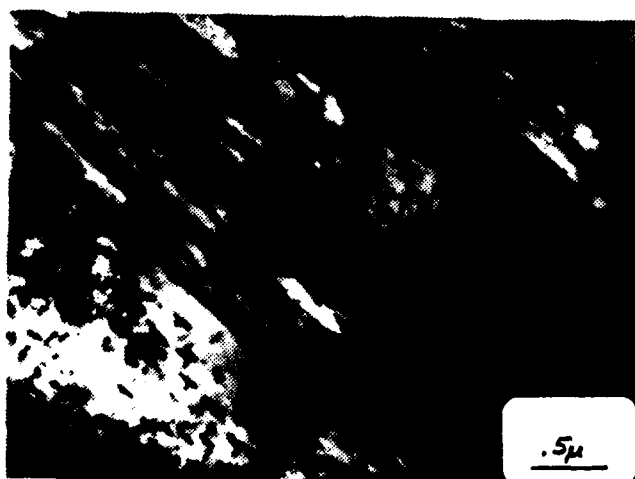
Figure 16

Bainite I comprises a large fraction of the microstructure in regions representative of the HAZ at a distance of 1.0mm. away from the fusion line. (Figure (16)) The large regions of bainite and the associated rod-shaped Widmanstatten carbides are shown in sharp contrast to the highly dislocated lath martensite. Region 3 shows the relatively wide bainitic laths and the narrow martensitic laths with retained austenite being suspected at the lath boundaries. Region 4 clearly shows the rod-shaped Widmanstatten carbides precipitated at dislocations within

MICROSTRUCTURES AT 1.0mm.
DISTANCE FROM FUSION
LINE, ALL PHOTOGRAPHS
AT 22,000X WITH
TEM

The region of the HAZ that is 1.0mm. away from the fusion line, figure (16), is much like that of the previous region with bainite I and martensite being the predominant microstructure. There are large numbers of rod-shaped Widmanstatten carbides precipitated at dislocations within the bainite laths, and a smaller number of rod-shaped

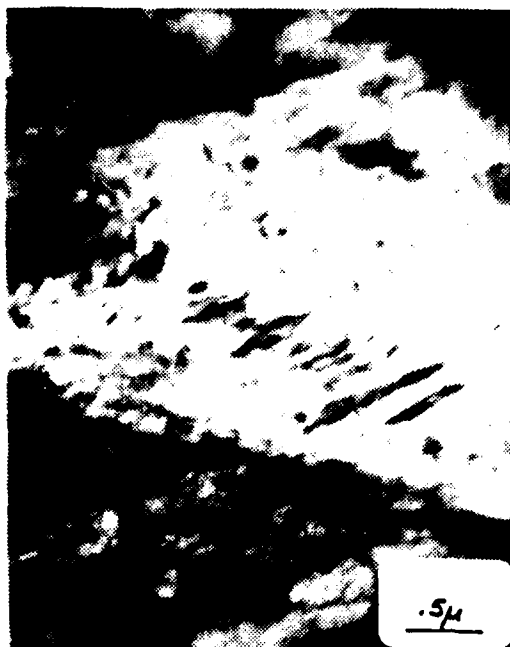
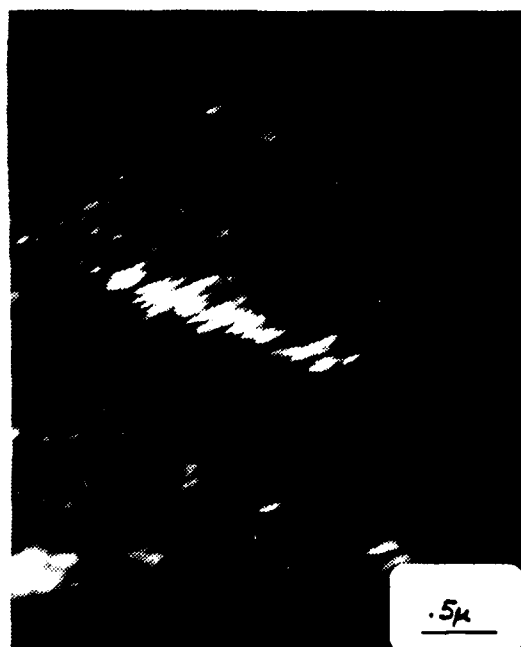
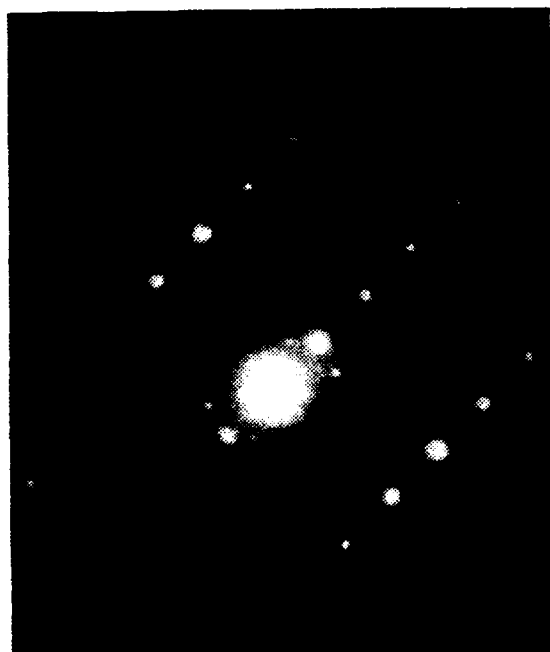
Figure 17

the wide bainite I laths. Figure (17) shows the dark field-bright field microstructures from a region of section 4 with the presence of twinned martensite in the wide laths encompassing the Widmanstätten carbides. This twinning is not characteristic of such a slow cooled weldment, but is known to occur in bainite I as a result of alloy segregation. [Ref. 11] The associated selected area diffraction pattern reveals this twinned martensite and is shown in the same figure.

MICROSTRUCTURE SHOWING TWINNED MARTENSITE IN THE UPPER
BAINITE OF REGION 4

SELECTED AREA
DIFFRACTION OF ABOVE
SHOWING TWINNED
MARTENSITE

carbides appear in the narrow martensite laths, indicating some autotempering may have occurred. Twinned martensite was occasionally found in this region, probably due to alloy segregation, figure (17). There is some retained austenite suspected in this region, which is reasonable when the rapid cooling rate from 1170°C experienced by this region is considered. Chen and Thompson [Ref. 12] illustrate similar micrographs of retained austenite in their work, especially in regions of upper bainite.

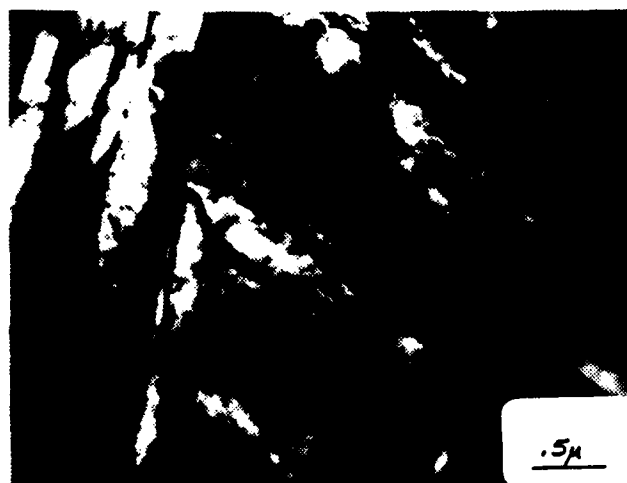
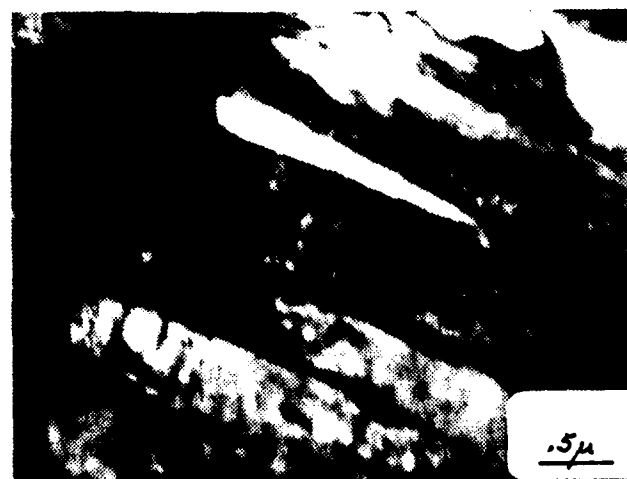
Figure 18

The fusion line region is shown in figure (18) and for the first time. Bainite III (lower bainite) is observed. The acicular bainite laths show some carbides at boundaries and interior regions. The amount of carbides visible has greatly decreased from those seen in other regions of the HAZ, and the laths are narrower and shorter than those of bainite I.

MICROSTRUCTURES AT
FUSION LINE, ALL
PHOTOGRAPHS AT 22,000X

The sections representing the fusion line, as shown in figure (18), are subjected to a temperature of approximately 1536°C. The microstructure consists of primarily lower bainite. Carbides are not visible and, since the temperature (1536°C) would be high enough to ensure complete solutioning of the carbon and the possibility of some mixing with weld metal, the M_s temperature would be lower at the fusion line than for any other region of the HAZ, thus allowing lower bainite to form. The cooling rate in this region is fairly rapid, and is at least 17°C per second given by Sorek, [Ref. 9] which exceeds the 8°C per second cooling rate required for martensite formation as discussed by Holsberg. [Ref. 15] Another explanation for the lower bainite present at the fusion line is that dilution of the base metal (5% nickel) probably occurred, mixing with the weld metal (2.76%nickel) producing a lower hardenability and
